## **ROLLING HILLS ELEMENTARY SCHOOL**

Rolling Hills Elementary was built in 1999 and is the newest addition to the Mukwonago Area School District. The building contains approximately 64,900 gross square feet on the first floor, with a partial mechanical mezzanine above of nearly 4,400 gross square feet. The exterior wall is load bearing masonry cavity walls type construction. The roof structure over the flat roof consists of steel columns, beams, joists, and a built up roofing system. The pitched roof over the mechanical mezzanine consists of wood trusses, and standing seam metal roof.

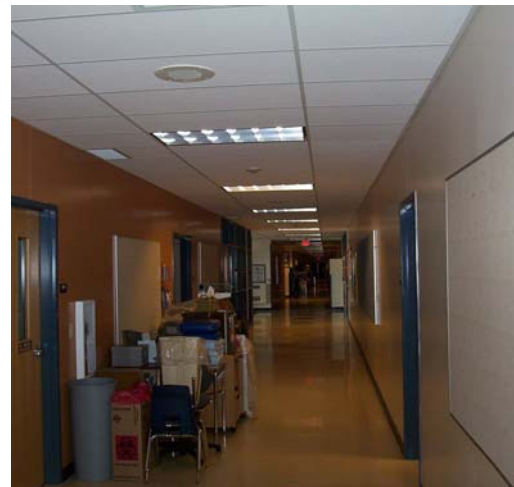
*The majority of the interior lighting at this building is T8 fluorescent with parabolic fixtures. Two-lamp fixtures are spaced 12' on center in the corridors and three-lamp fixtures are spaced 10' on center in classrooms. Both areas appear dark and District Buildings and Grounds staff indicated lighting upgrades as a possible project at this school to correct this. However, this relighting is not strongly recommended unless students and staff are complaining of eye strain.*

*1.4 Option A: Remove and relocate existing fixtures in classrooms and corridors to 8' on center and add additional fixtures to match existing.*

*Option B: Remove existing fixtures in classrooms and corridors and replace one for one with new troffers in lieu of parabolics.*

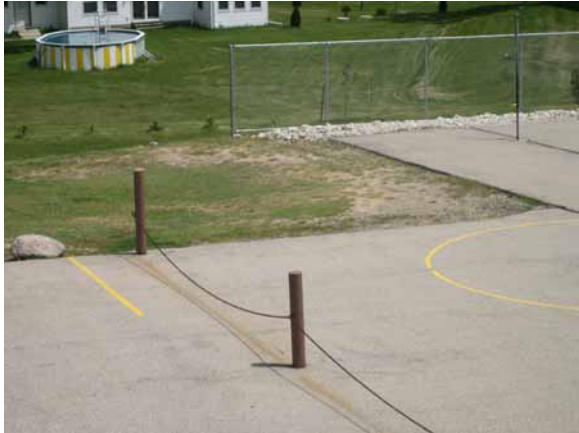
- 1.2 *Several large cracks have appeared in the asphalt playground, on the east side of the building, and will need to be repaired.*

1.2 Asphalt paving at playground

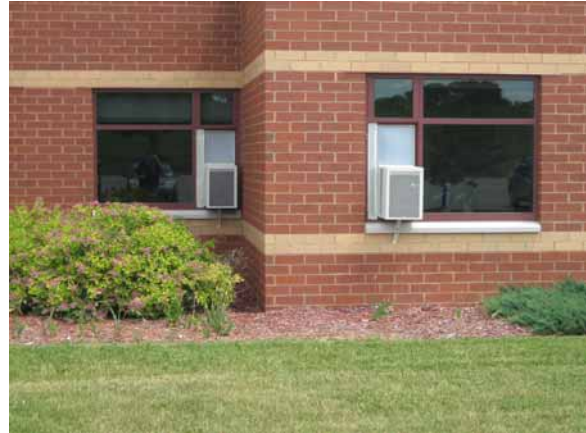
- 1.5 *Landscaping around the perimeter of the building is in good condition.*  
1.6 *Landscaping at the edge of the playground and parking lot is in poor condition, where most of the grass has eroded away. Reseed Lawn.*

1.5 Landscaping at perimeter of building

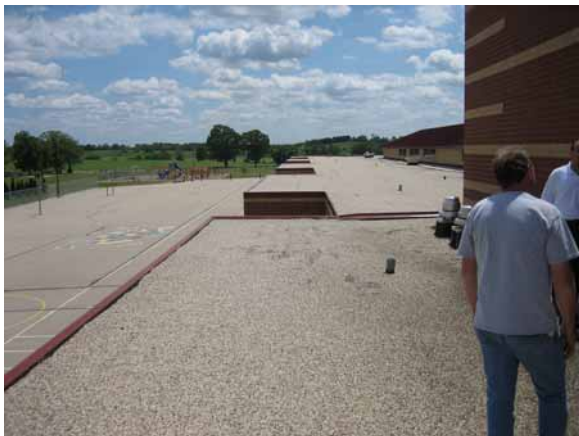
- 2.2 *Roof was new in 1999 and is in good condition.*  
2.3 *Leaks have appeared at the connection between the flat roof and the west and east wall of the gym. A repair was made, but water continues to leak down the wall in these areas. Also, the flexible flashing used in the walls of this area is failing and should be repaired.*

2.2 Roof

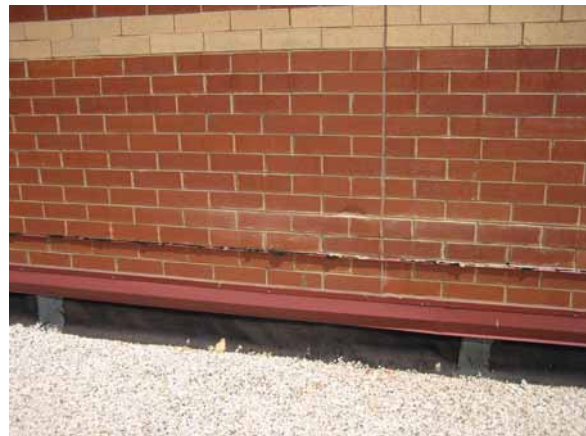
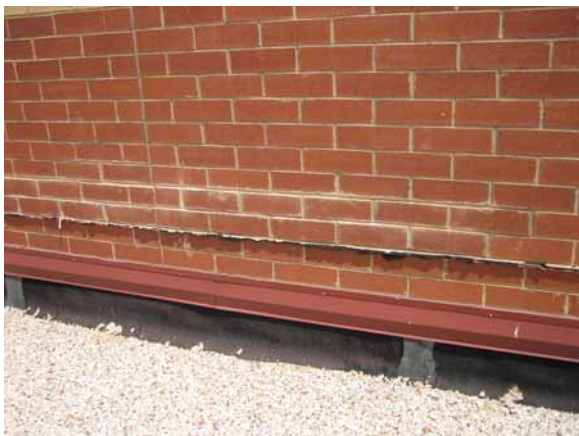
2.3 Brick repair at gym wall

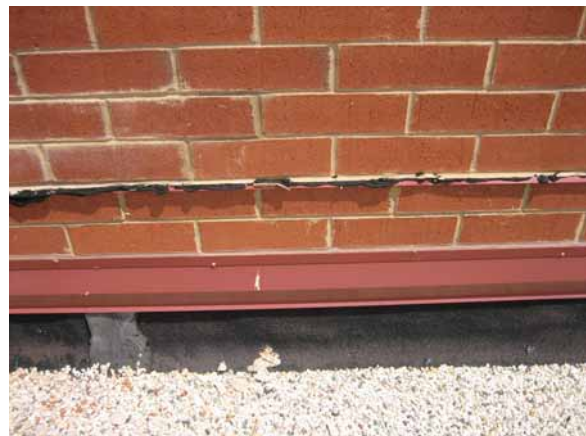
2.3 Flexible membrane flashing failure at gym wall

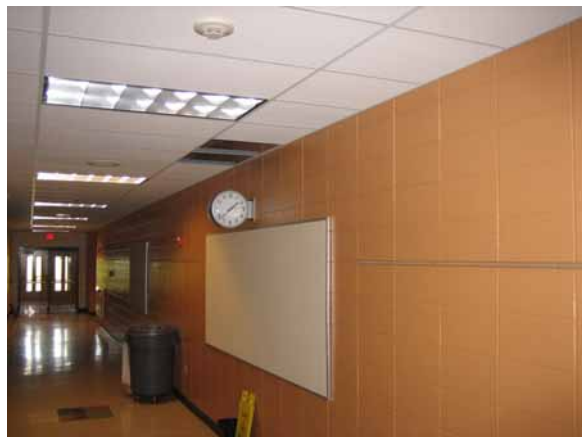
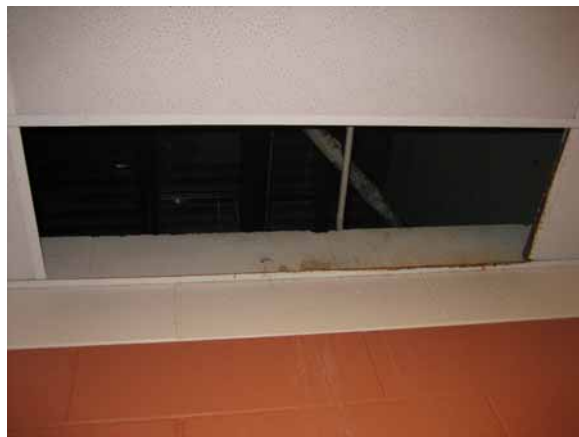
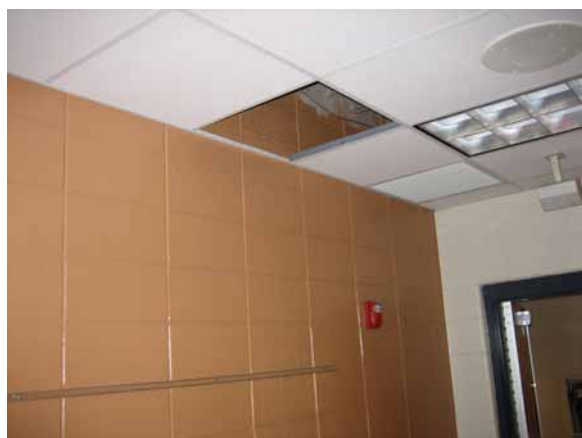
2.3 Interior leaks from roof above

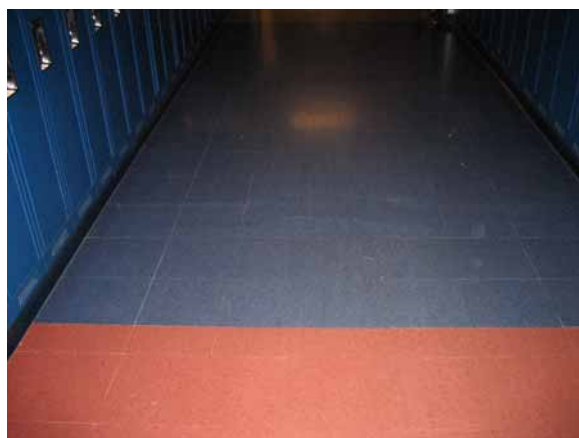
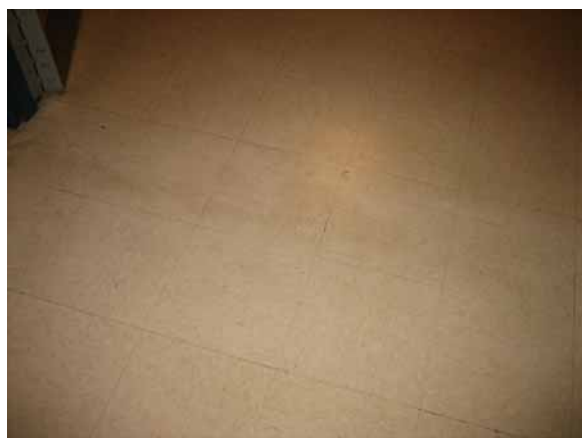
4.7 *The tile/carpets around the building are in good condition. A few areas of tile flooring are cracked and need to be replaced. The gym epoxy floor shows signs of bubbling and should be repaired. The hallway and classroom floors have huge cracks.*

4.7 Floor tile

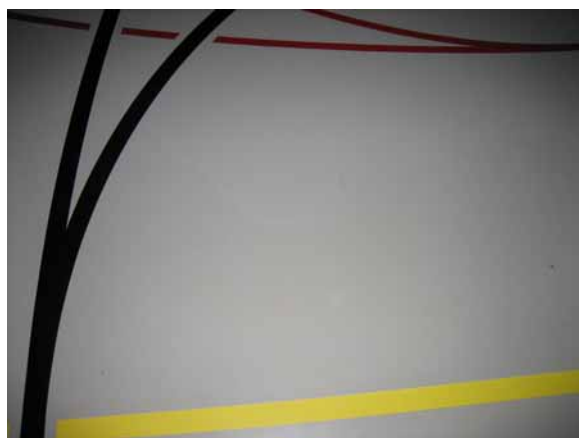
4.7 Gym floor

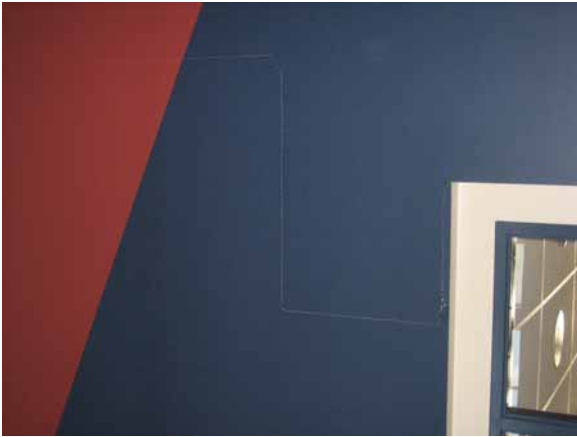
4.9 *Painted walls around the building are in good condition. Cracks in the library walls have appeared and should be repaired and repainted.*

4.9 Cracks in library walls
